***NPDES
Inspection Report***

***BMC West Truss & Components
Everett, WA***

***April 29th, 2016
May 10th, 2016***

***Brian Levo
Environmental Protection Agency, Region 10
Office of Compliance and Enforcement
Inspection and Enforcement Management Unit***

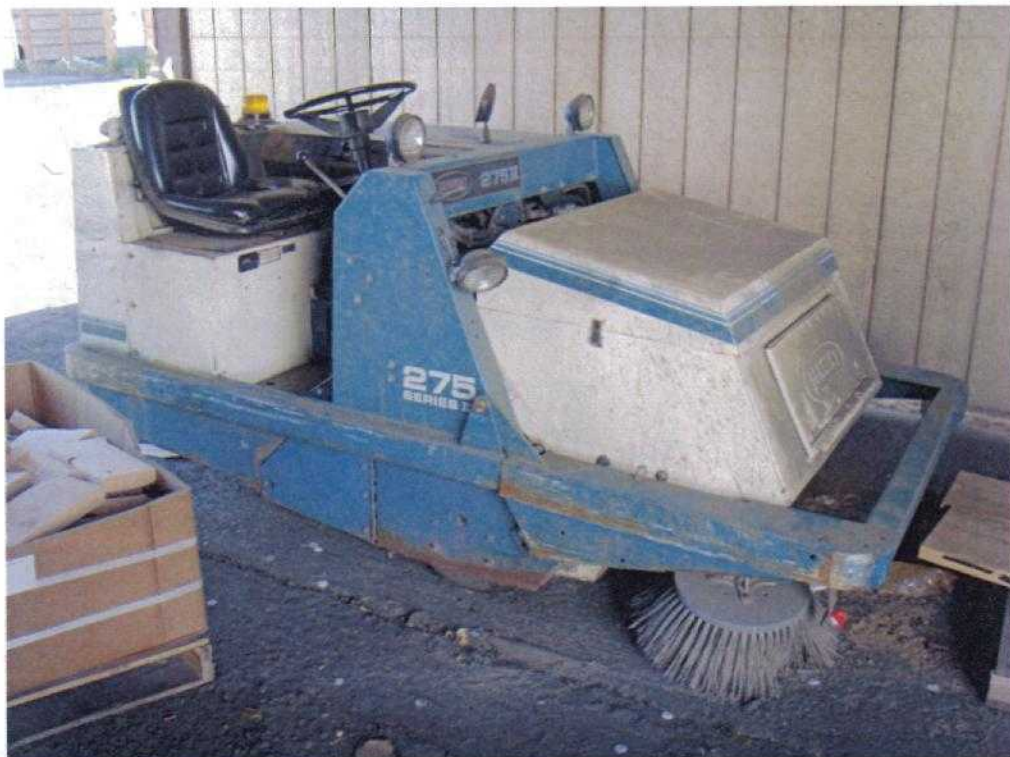
Photo 27 (SI850543): 'Mini-Zamboni' sweeping machine.

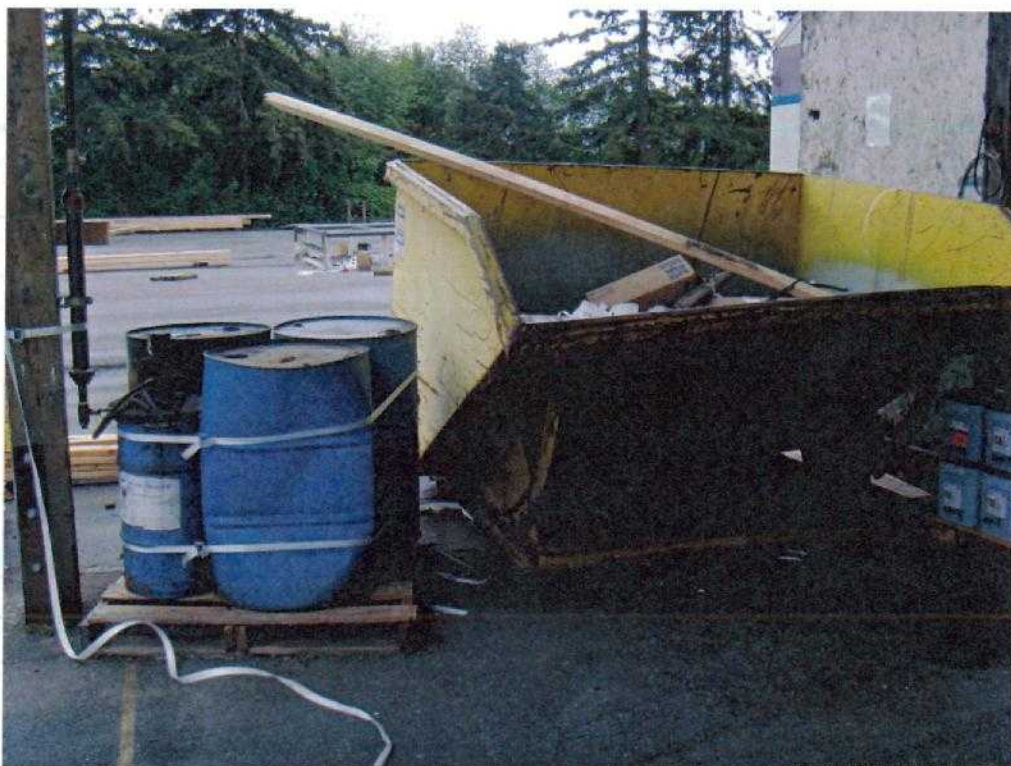
At the southeast corner of the miscellaneous storage building #2, were three 55-gallon drums and a small drum labeled as 'Ultra-Duty Grease' stored without secondary containment, as well as, a waste bin without a lid (**Photo 28**). At the time of the 4/29/16 inspection, I noted several other waste bins without lids throughout the facility that contained wood scraps and miscellaneous garbage (**Photos 31-37**). Mr. Waldron said that these waste bins do not have lids and that BMC consolidates the contents of the various waste bins in the large dumpsters on an as-needed basis.

Photo 28 (SI850513): Three 55-gallon drums and a small drum stored without secondary containment, and a waste bin without a lid, on the south side of the miscellaneous storage building #2. Two of the 55-gallon drums were open at the top and were partially filled with liquid.

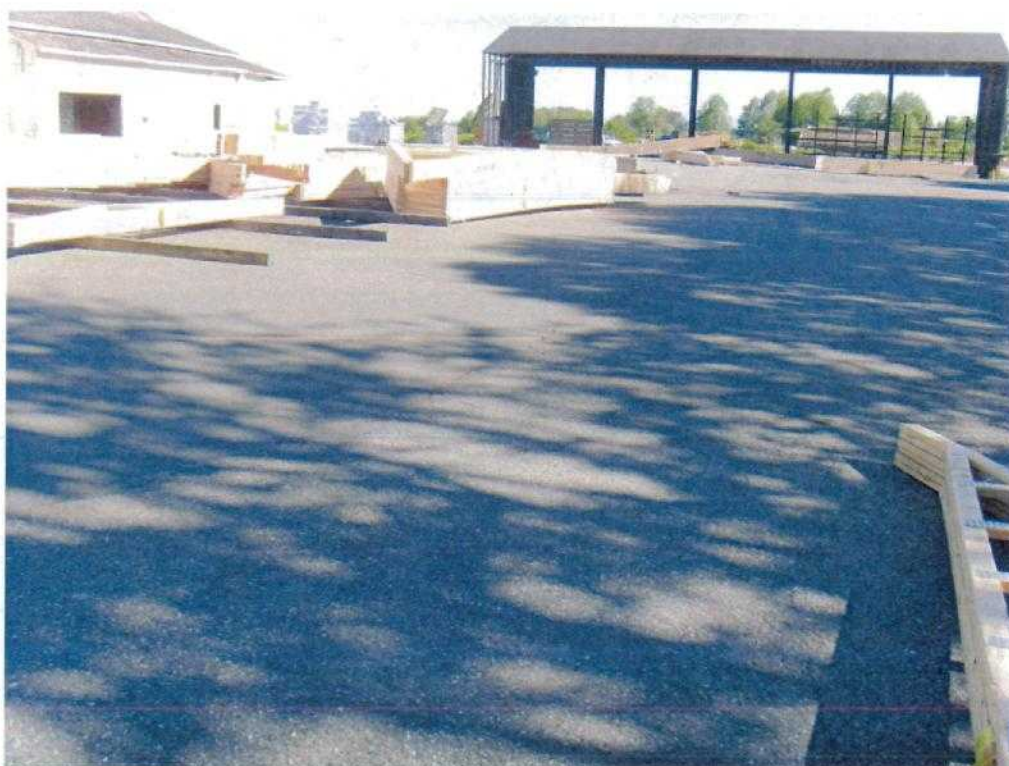
Manufactured trusses were stored in a yard on the southeast side of the facility (**Photo 29**). Mr. Langlois said that the trusses are made of untreated wood, but they also have some small metal components. I noted that the center part of the truss yard slopes to a low spot near the southeast corner of the BMC property (**Photo 30**). Vegetation present along the boundary of the yard made it unclear where stormwater from this area flows.

Photo 29 (SI850546): Northern view of the area that drains to the low spot on the southeast side of the built truss storage yard.

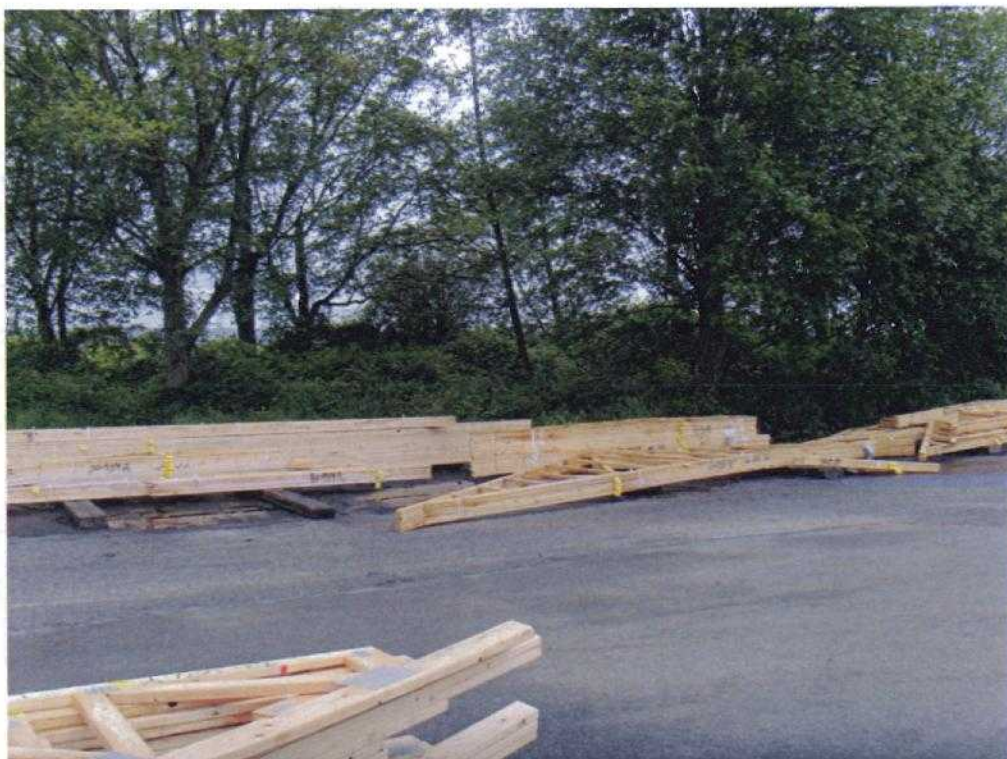
Photo 30 (SI850512): Low spot on the southeast side of the built truss storage yard.

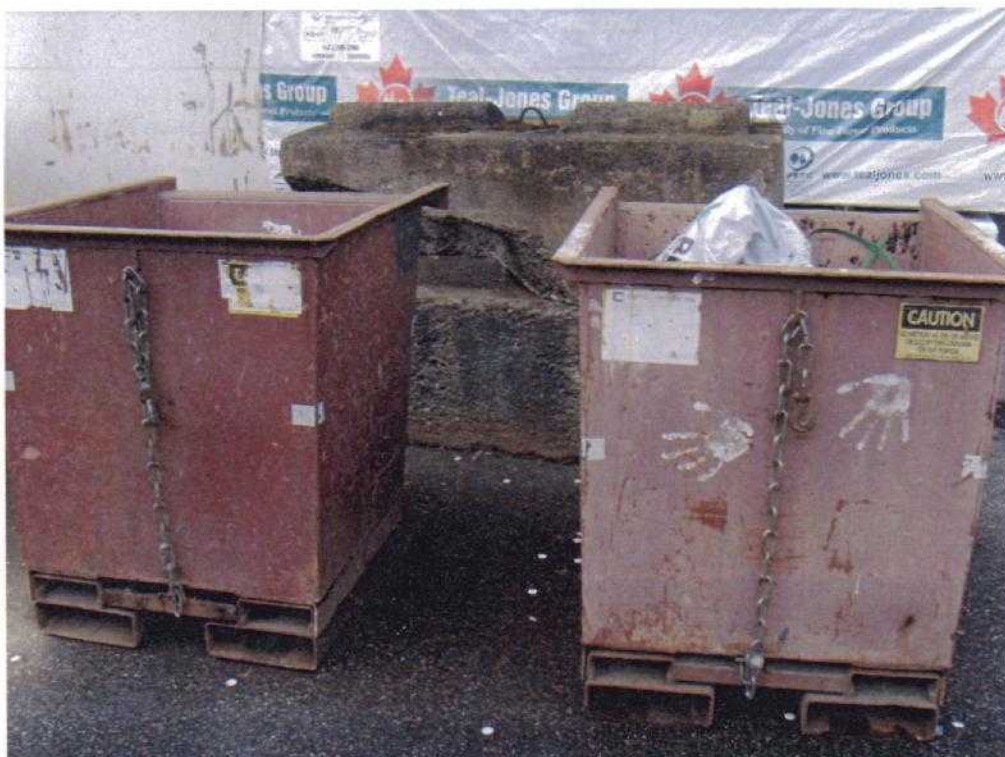
Photo 31 (SI850515): Two small waste bins without lids on the east side of the lumber storage and lumber cutting buildings.

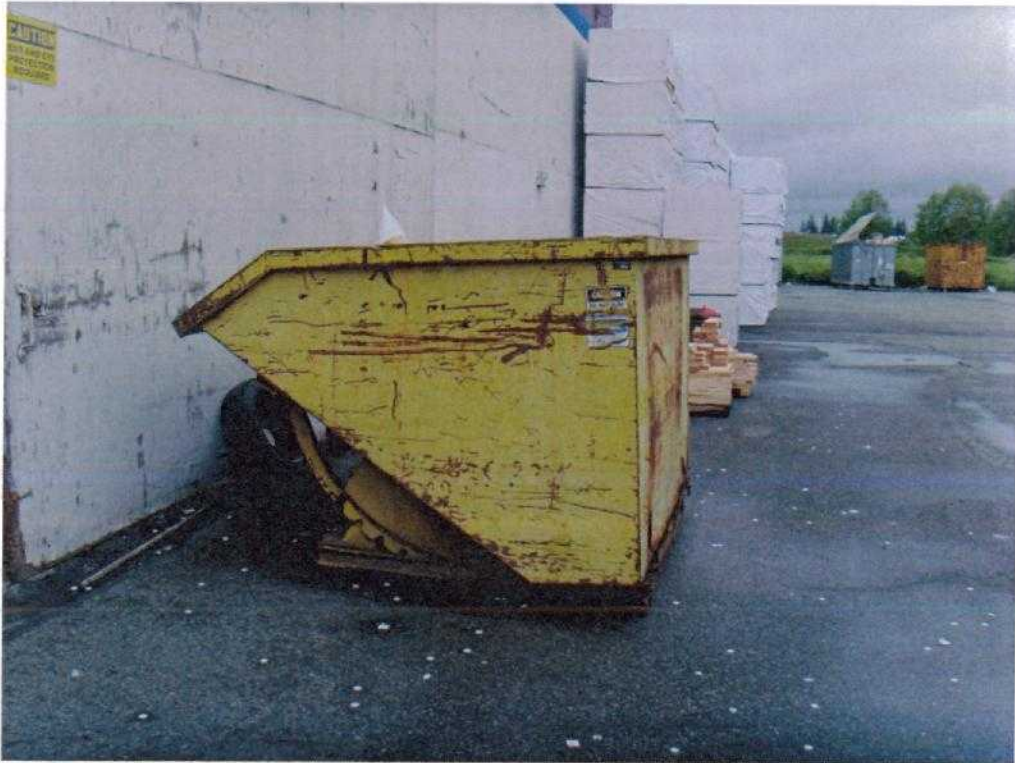
Photo 32 (SI850516): A waste bin without a lid on the east side of the lumber storage and lumber cutting buildings.

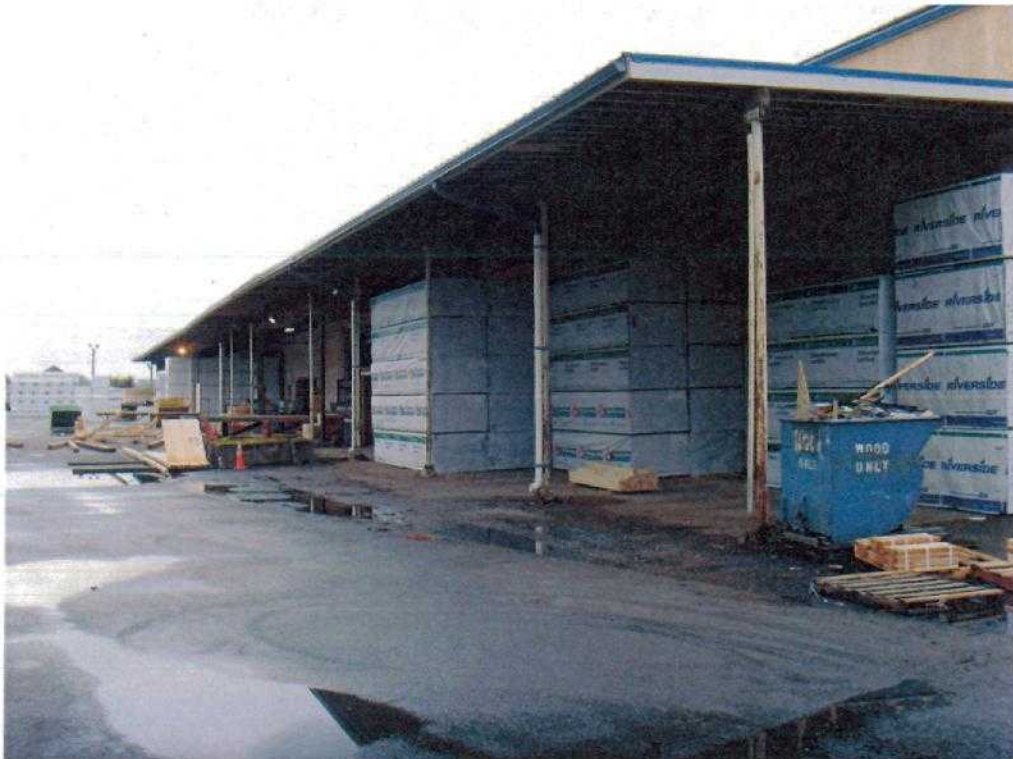
Photo 33 (SI850518): Western view of the south side of the truss manufacturing building. Note the wood waste bin without a lid on the right side of the photo.

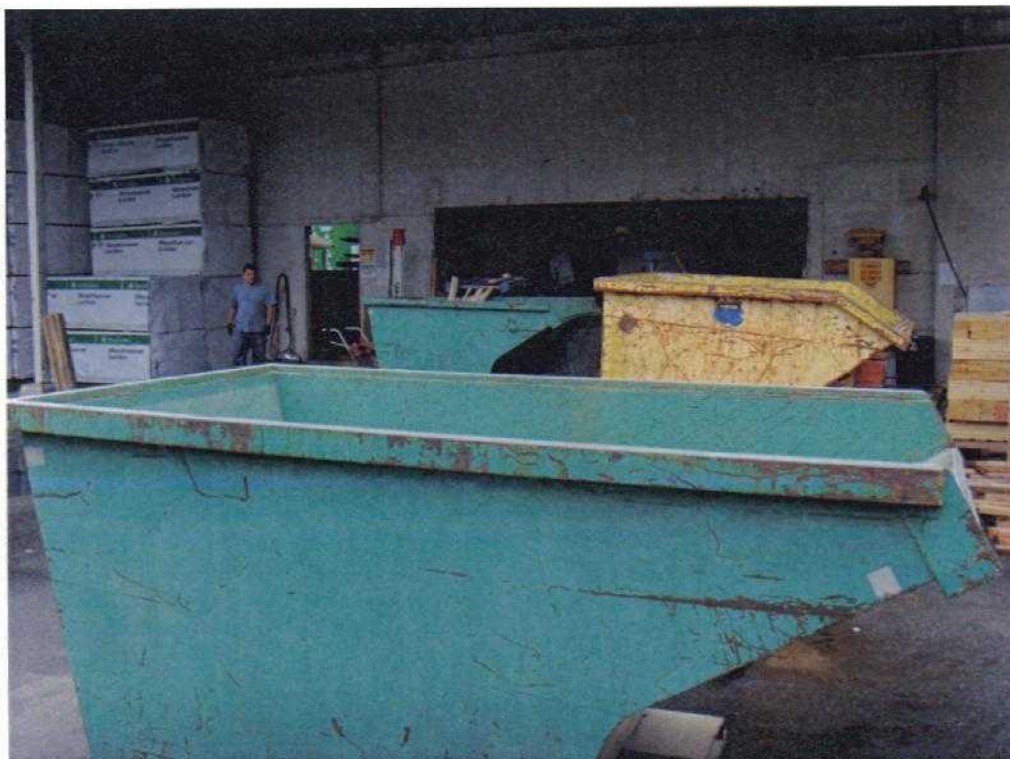
Photo 34 (SI850519): A waste bin without a lid on the south side of the truss manufacturing building.

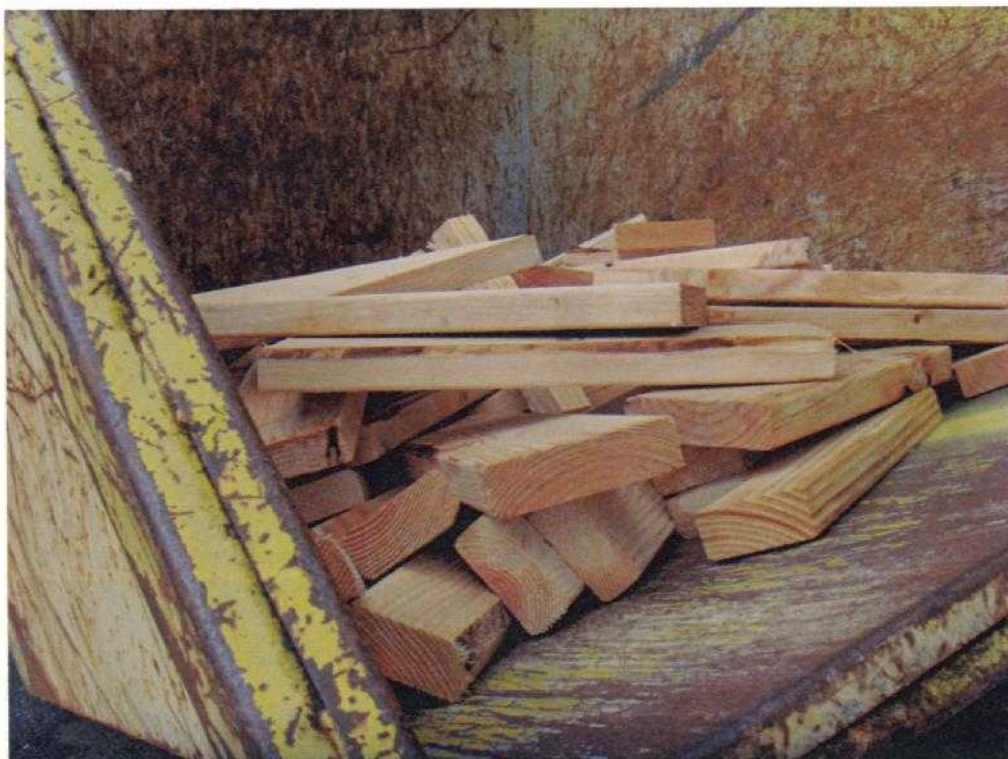
Photo 35 (SI850520): View inside a wood waste bin without a lid on the south side of the truss manufacturing building.

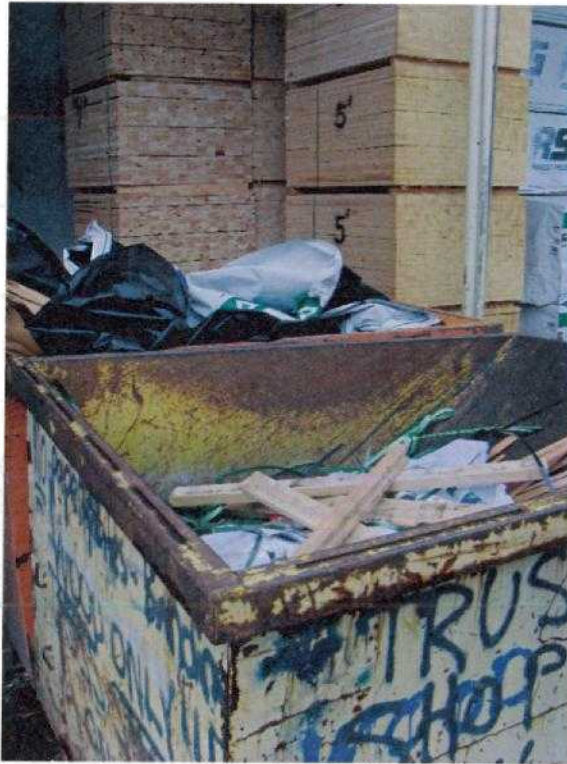
Photo 36 (SI850523): A waste bin without a lid on the south side of the truss manufacturing building.

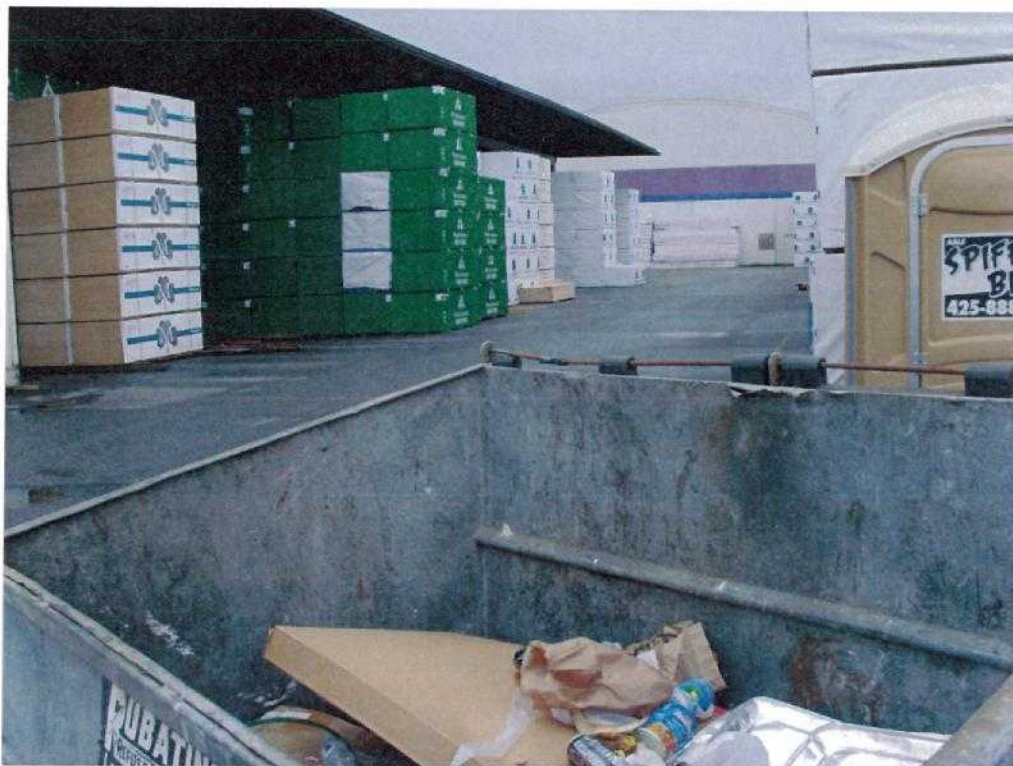
Photo 37 (SI850524): A dumpster without a lid at the northwest corner of the truss manufacturing building.

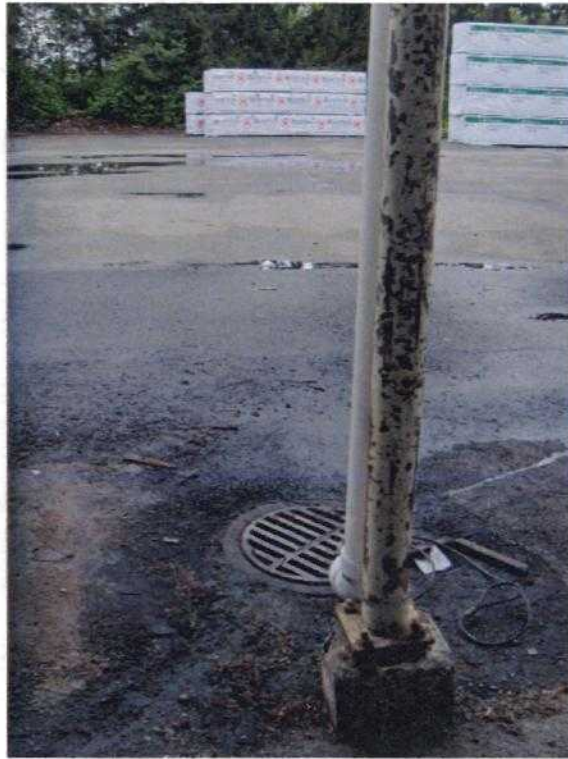
Catch basin #01 was located near the southwest corner of the truss manufacturing building (**Photo 38**). At the time of the 4/29/16 inspection, there was sediment in close

proximity to catch basin #01. Mr. Waldron said that unpaved areas south of the office may be in part responsible for this sediment. I noted that stormwater filter inserts were not installed in this drain on either 4/29/16 or 5/10/16. Mr. Waldron said that filter inserts were not being implemented at this catch basin.

Photo 38 (SI850522): Southern view of storm drain #01. Note the sediment in proximity to the drain. This photo was taken on 4/29/16.
